National Energy
Board

Investigation under the *National Energy Board Act*

9 July 2006 ruptures of the Pine River Gas
Plant Sulphur Pipeline, owned and operated by
Westcoast Energy Inc. carrying on business as
Spectra Energy Transmission

June 2009

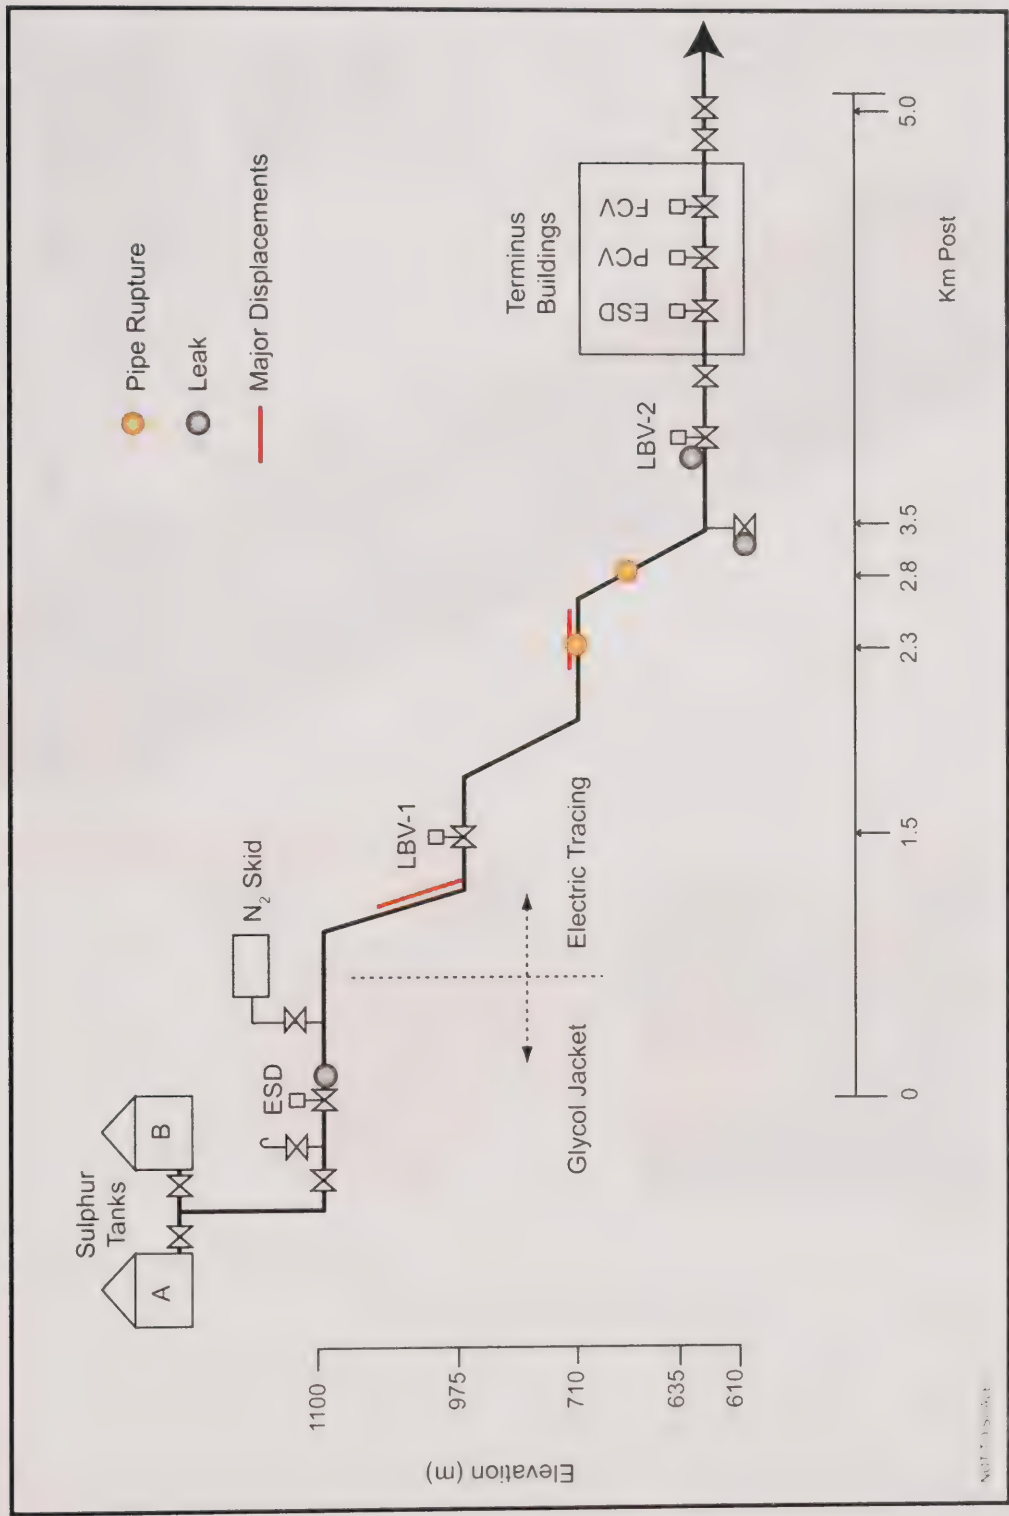
Schematic Diagram of Sulphur Pipeline Damages

The sulphur pipeline sustained ruptures at 2.3 km and 2.8 km, as well as damaged anchors and displacement of the pipe from its supports at 1.5 km, 2.3 km, and 2.8 km. The condition of the pipe was examined by removing insulation at piles along the pipeline. Measurements confirmed the pipeline had expanded in diameter by as much as 3.8% near the 2.3 km rupture and 5.7% downstream of the 2.8 km rupture⁶. The rupture at 2.3 km occurred on the inside radius of the last 90 degree elbow of an expansion joint. The anchors were damaged and the pipe was completely displaced from its supports. The rupture at 2.8 km occurred on a straight section of pipe located on a slope. Pipe at this location was displaced on its supports.

The total loss of power, solidification of sulphur in the pipeline, and overpressure upon remelting, eventually led to ruptures at 2.3 km and 2.8 km on the sulphur pipeline. Laboratory examination of the failed material at both locations revealed acceptable material properties and the cause of failure was determined to be stress exceeding the tensile strength of the material.

Spectra repaired all damaged anchors, tie-rods, supports and shoes prior to returning the sulphur pipeline to service. Spectra and its consultants reviewed design of anchor and tie-rod assemblies and determined that the design is acceptable for foreseeable operational dynamic events related to normal operation.

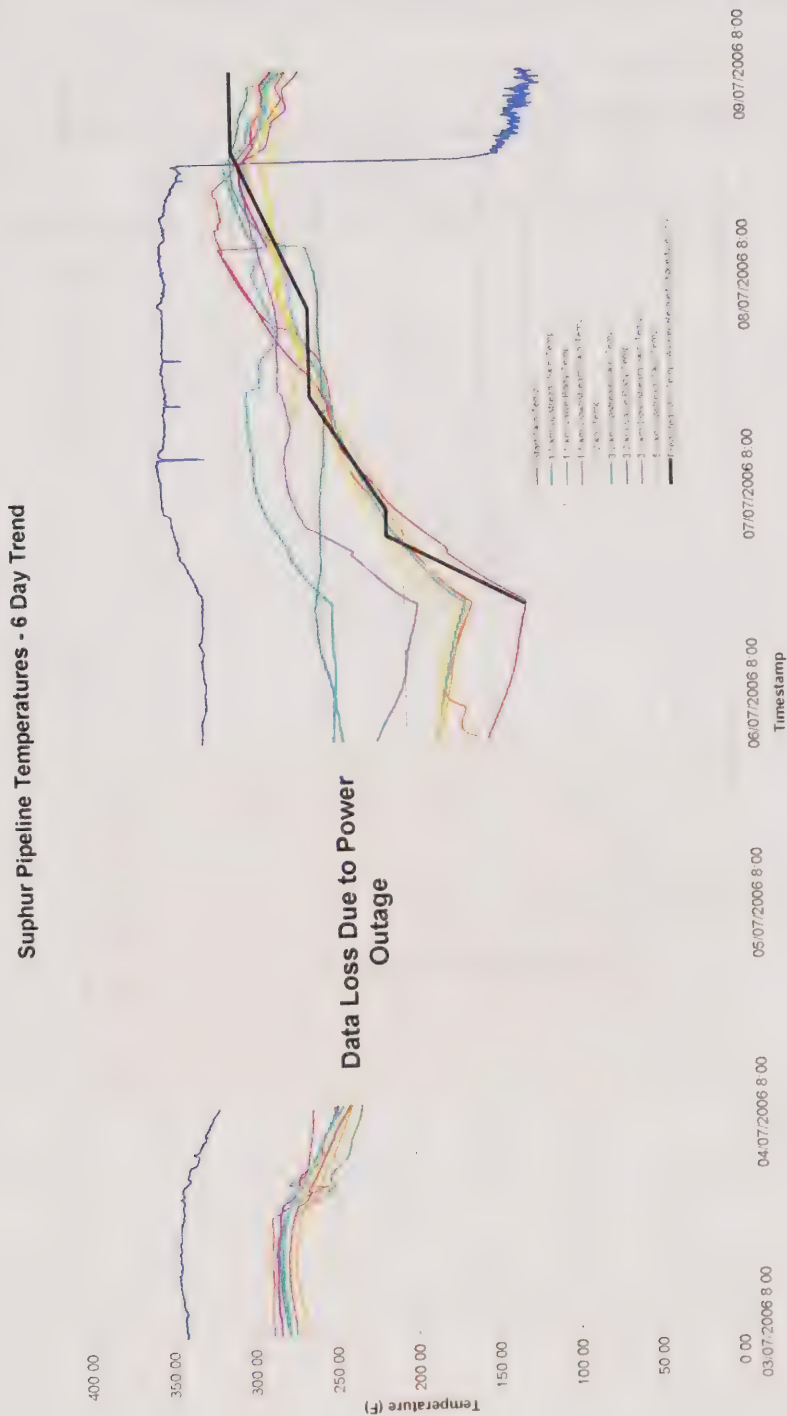
Sulphur Pipeline Time-Temperature Profile

In practice however, when the remelt procedure was initiated upon restoration of power, the controlled temperature increases and hold periods could not be achieved (the time-temperature profile is provided in Appendix VI). The uneven heating observed during the remelt procedure may have been a result of initiating the procedure when: temperatures varied greatly throughout the pipeline (between 52°C and 163°C); sulphur in the pipeline was at varying degrees of solidification; sulphur plugs and voids were present; there were heat sinks at discontinuities in the pipeline; or any combination thereof. Ultimately, the remelt procedure was unsuccessful and resulted in uneven temperatures and overpressure conditions that eventually ruptured the sulphur pipeline.

The procedure for remelting the sulphur pipeline was extensively revised¹⁹. The procedure now has a pre-condition for remelting, which is to ensure complete solidification of sulphur remaining in the pipeline by maintaining uniform temperatures below 37.8°C (100 F) for a 24 hour period. The new remelt methodology requires rapid heating of the heat tracing systems, which will melt a channel of sulphur immediately next to the heat tracing. This minimizes the volume of sulphur that will undergo phase change and expand. The sulphur pipeline is also to be melted in 7 pre-planned sections. The procedure identifies large commitments of time, resources, equipment, and monitoring, required to remelt the pipeline, as well as the need for every remelt to be analyzed by a team prior to execution.

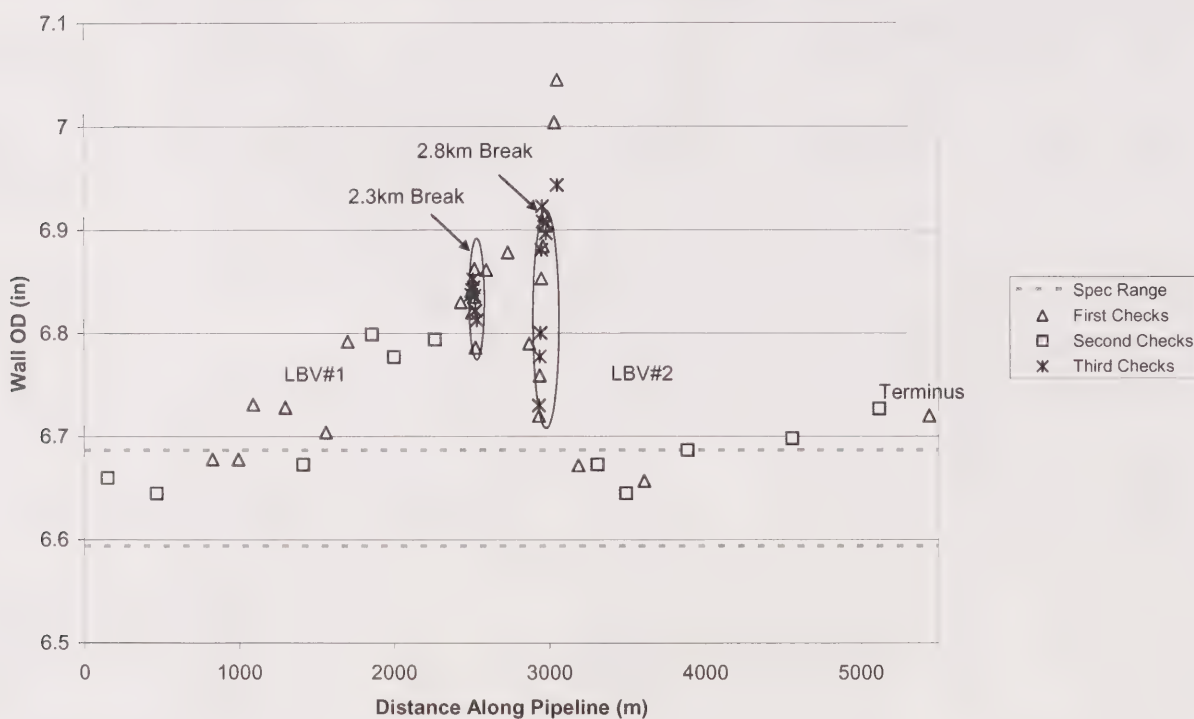
Figure VII-1: Sulphur Pipeline Outside Diameter Measurements

The overpressure at 2.8 km was likely caused by expansion of sulphur during phase change from solid to liquid between plugs of solid sulphur. The pipe experienced significant wall thinning adjacent to the SECT conduit, where expansion from phase change would be greatest. The effects of overpressure by expansion of sulphur during phase change are cumulative with each successive overpressure. Expansion of the pipe can occur each time the pipeline is subjected to the remelt procedure. Lab results from examination of the failure at 2.8 km showed no evidence of progressive failure; however, the pipe diameters at locations along the line expanded by up to 7% and are now at greater risk of cumulative effects.

The results of measurements along the sulphur pipeline are compiled in two plots, provided in Appendix VII. Measurements of the outside diameter were plotted against distance in Figure VII-1, with the range of specification ASTM A 106 for comparison. Expansion proved to be greatest in locations near the 2.3 km and 2.8 km ruptures and exceeded the range of the specification. Measurements of the wall thickness were also plotted against distance in Figure VII-2, with minimum and nominal wall thickness of specification ASTM A 106 for comparison. All wall thickness measurements were greater than the minimum specified by ASTM A 106.
